An **AAPTP** Research Report

Technical Guide AAPTP 05-04

**Techniques for Mitigation
of Reflective Cracks**

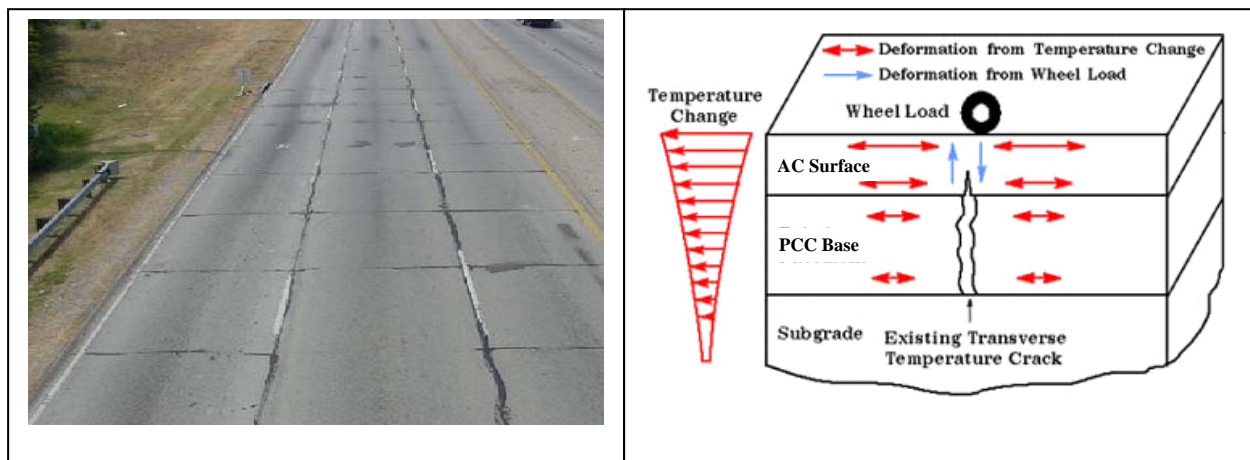
Figure 1. Reflective Cracking in HMA Overlays of PCC Pavements

The most common accepted cause of reflective cracks is from horizontal movements concentrated at joints and cracks in the existing pavement, and is referred to as thermally induced cracking (refer to figure 2). These horizontal movements are caused by temperature changes in the PCC slab. This development of reflective cracking due to environmental loadings are dependent upon the magnitude and rate of temperature change, slab geometry, gauge length across the joint or crack, and properties of the resurfacing material or overlay. Because of the bond between the HMA overlay and existing pavement, the tensile stresses and strains produced from joint movements become critical in the areas of the PCC joints and cracks (figure 2.a). Thus, all of these factors must be included in the evaluation of the environmental effects or loadings on the HMA overlay.

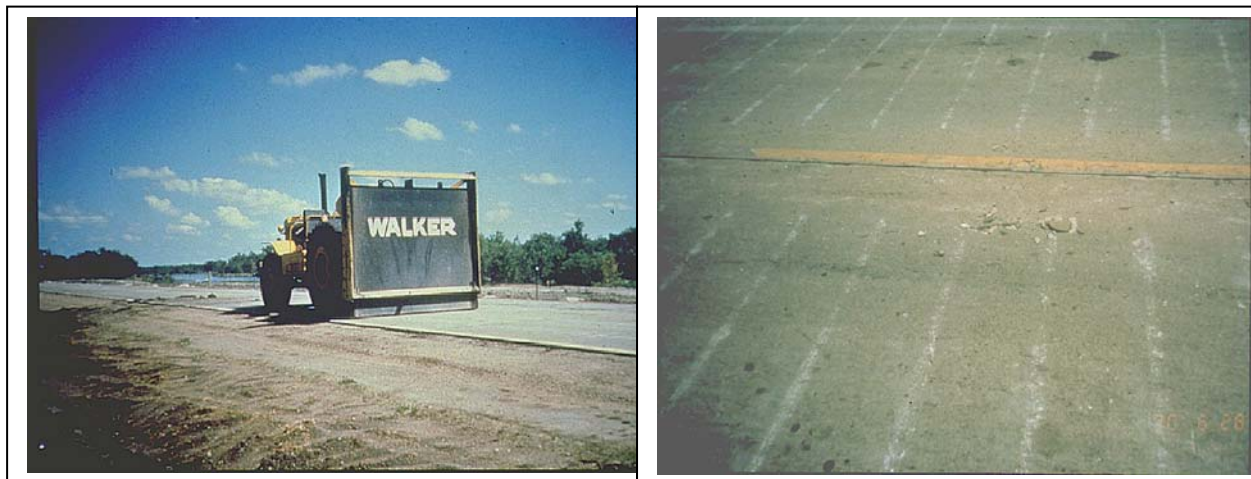
Figure 7. Crack and Seat or Break and Seat Equipment for Fracturing PCC Slabs

The crack or break and seat technique produces shorter slabs (2 to 6 ft. [0.6 to 1.8 m] in length), while retaining structural integrity by inducing fine, vertical, transverse cracks in the jointed concrete pavement. The break and seat method refers to jointed plain concrete pavement (JPCP), while the crack and seat method refers to jointed reinforced concrete pavements (JRCP). The fracturing process reduces the effective length of the slab between the contraction joints. Figure 7 shows the equipment used to fracture the PCC slab and the transverse cracks that are created.

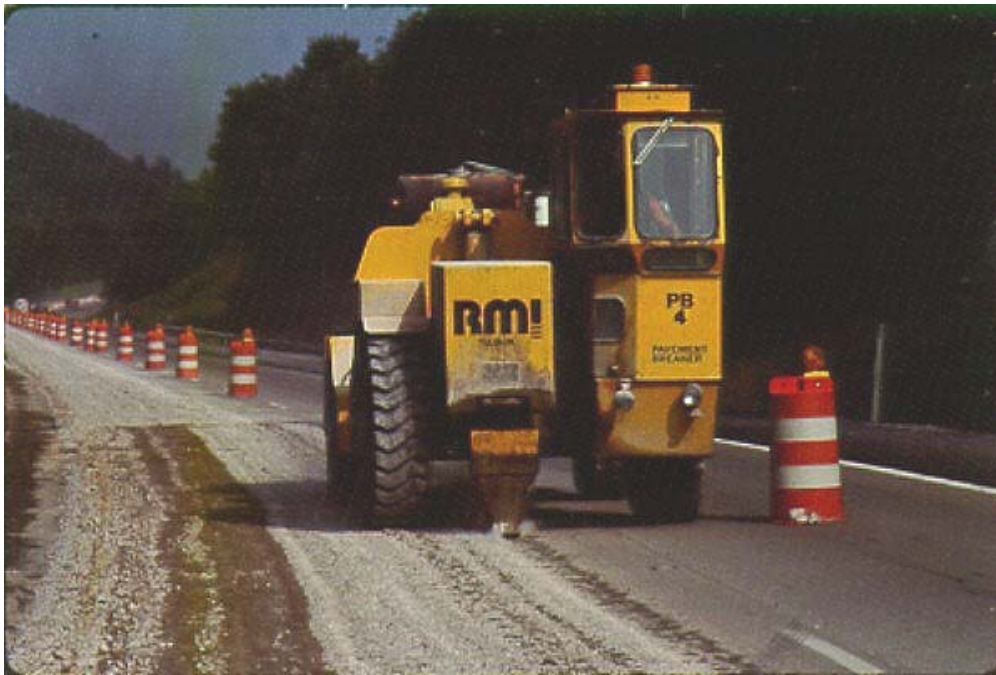
Figure 8. Resonant Frequency Pavement Breaker for Rubblizing PCC Slabs

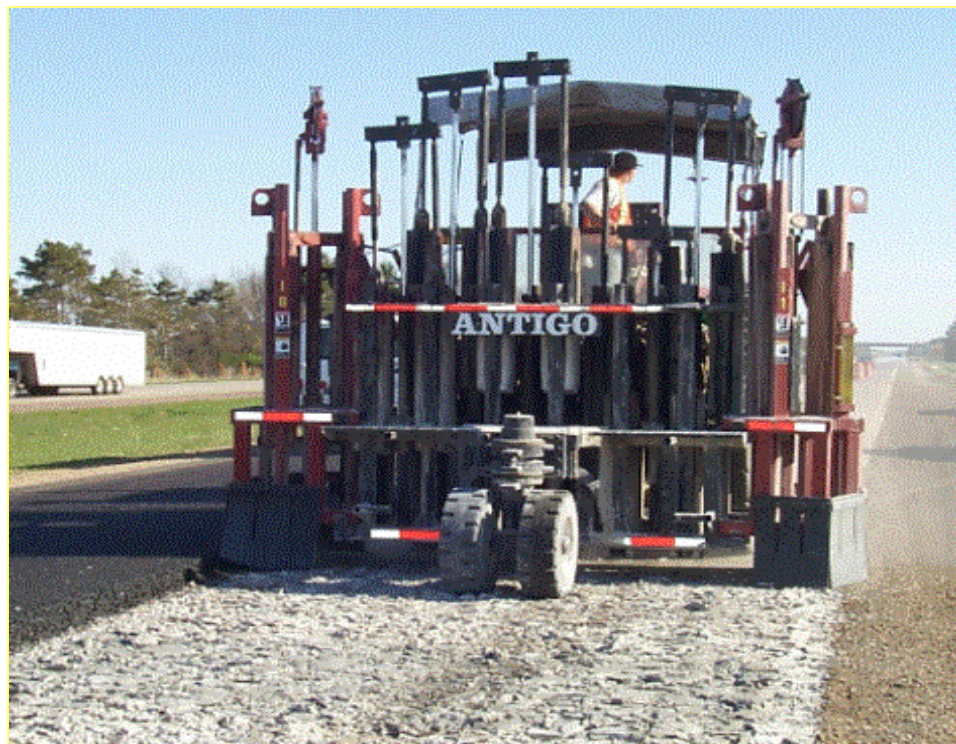
Figure 9. Multiple-Drop Hammer for Rubblizing PCC Slabs

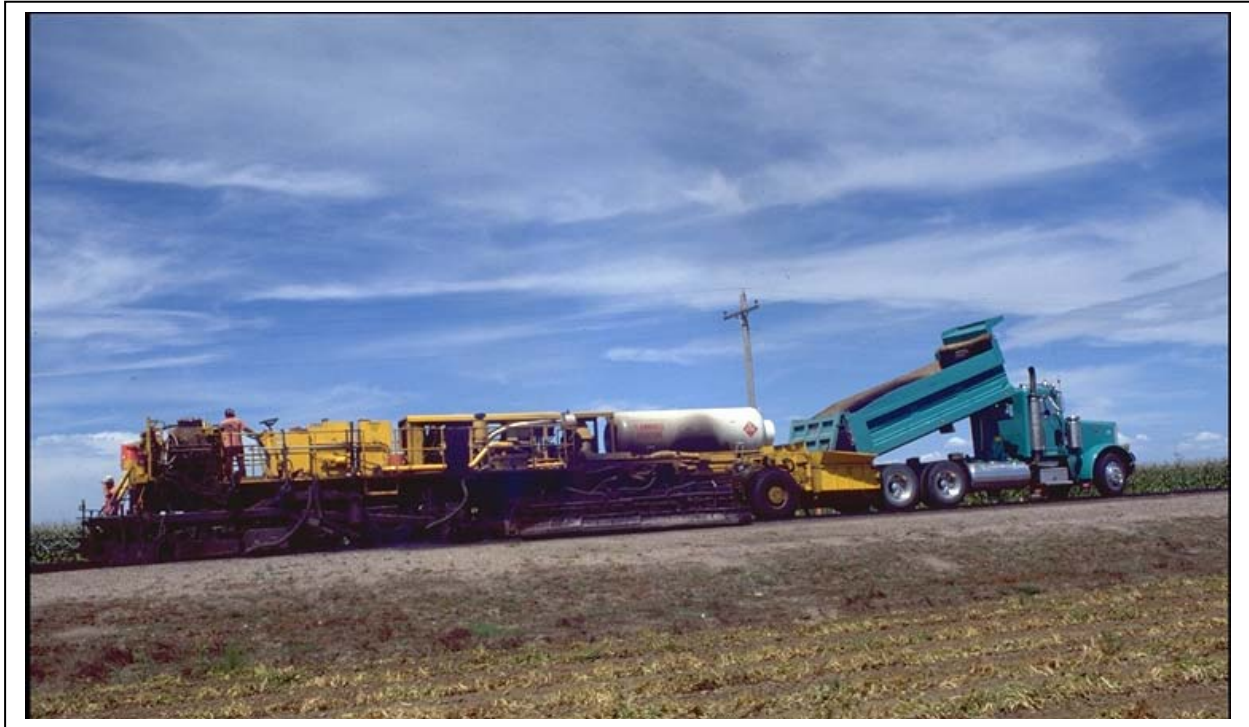
Figure 10. Hot In Place Recycling Method of Flexible Pavement

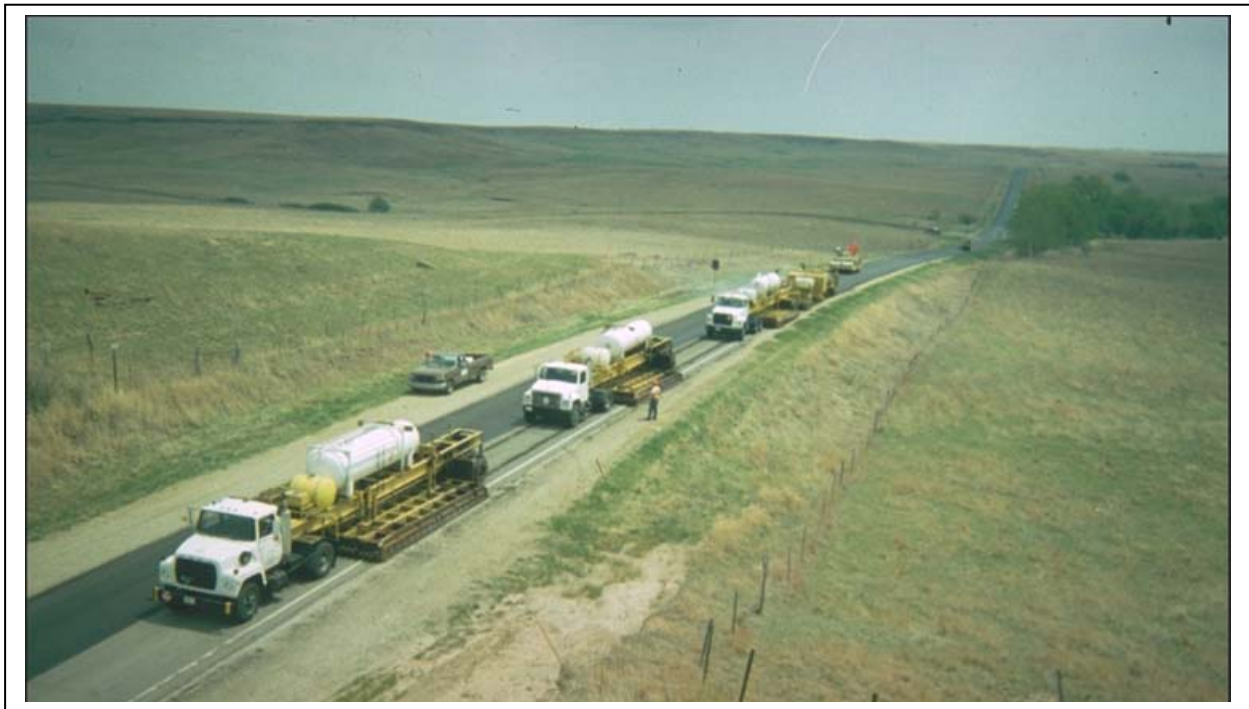
Figure 11. Heater Scarification of HMA Surfaced Pavements

The heater scarification technique scarifies the existing pavement surface to a depth of approximately 0.75-in (19 mm) so that the upper portion of any crack can be removed along with any crack sealant. The lower portion of the crack can be sealed through the heating process. The remixed and re-compacted layer becomes a uniform uncracked layer above the crack tip. As a consequence, the reflective cracking of the HMA overlay should be delayed.

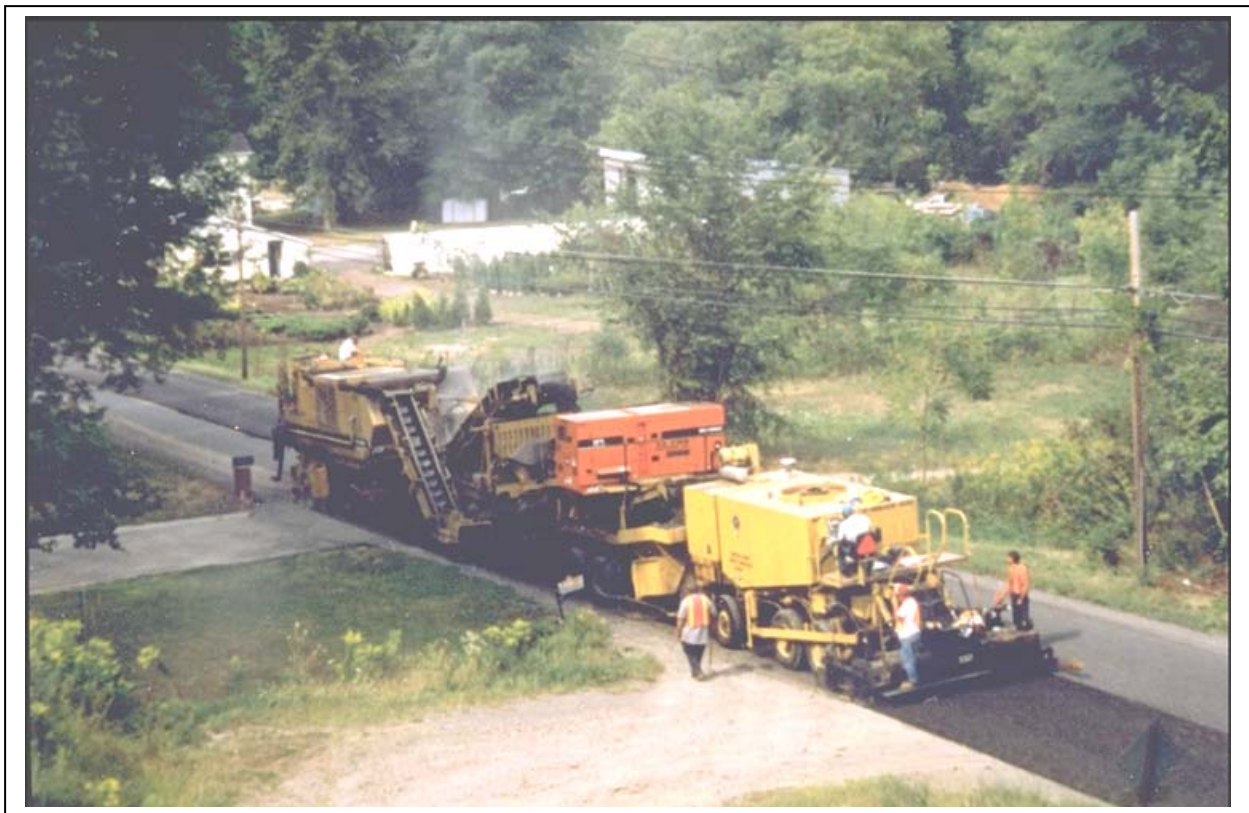
Figure 12. Cold In Placed Recycling Method of Flexible Pavements

The full-depth reclamation (FDR) method is a cold in place recycling (CIPR) method. Figure 12 shows the equipment used for the CIPR process. In summary, the existing HMA layers are pulverized in place eliminating all cracking. A bituminous binder consisting of various emulsions or foamed asphalt (with or without cement or lime-fly ash) is normally added to the pulverized material which is compacted. This method strengthens the HMA pavement because cracks are removed in place and that material is compacted forming new intact material. This method is hypothesized to be a reliable technique because the reclamation/recycling process eliminates all cracks in the existing HMA layers, and reflective cracking becomes a non-issue. The equipment, materials, and construction process is discussed in more detail in the FHWA's training course entitled Asphalt Roadway Rehabilitation Alternatives (1997).
